# Road Facility Availability and Maintenance in Lagos State, Nigeria

**Key words:** Road facilities, maintenance, road condition, Lagos metropolis

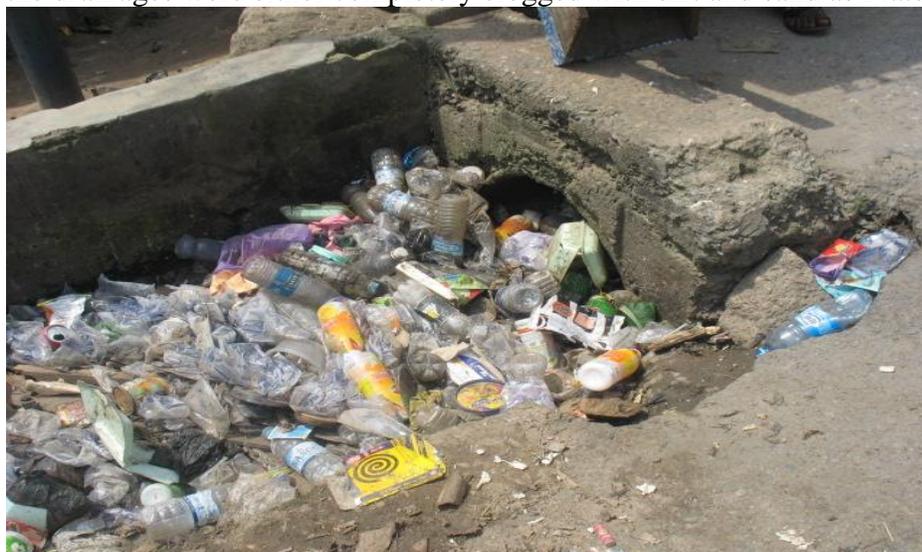
Plate 1: Blocked cuvert at Awofodu junction, Pedro Road

A higher proportion of the culverts have more than 60% space clogged by dirt. The clogged portion largely reduces the capacity of the culverts as channels for run-off water and flood control. The usefulness of the culverts at Pedro Road, Alayabiagba Street and Pedro Road (see Plates 1 and 2) is only in their presence and certainly not for flood control at their present state. It is pertinent to add that some of the culverts that are completely clogged at some points now complement the carriage way as pedestrians walk on them and danfo (commercial bus) drivers make illegal U-turns on them. The paucity of pedestrian bridges, traffic lights, and walkway make the roads less user friendly. Furthermore, the fewness of road side trash bins coupled with the care free attitude of most road users encourage indiscriminate disposal of trash on the roads and culverts.

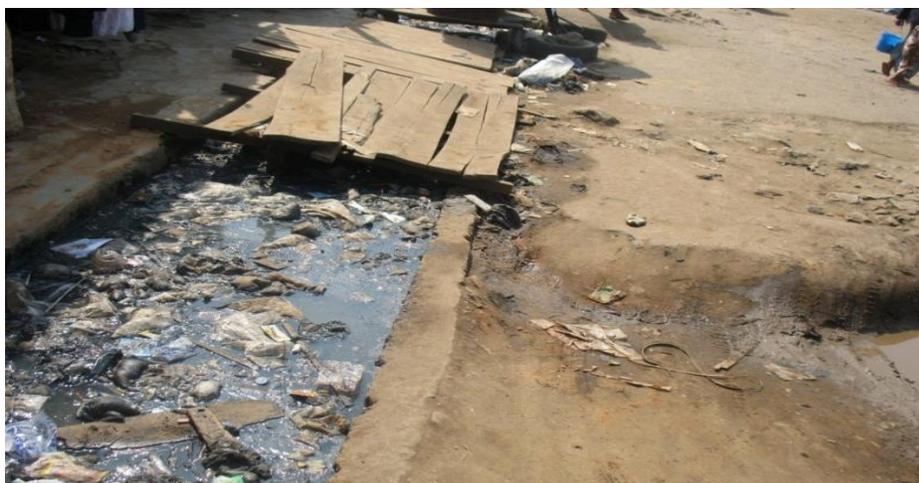
Plate 2: Clogged drainage on Alayabigba Street

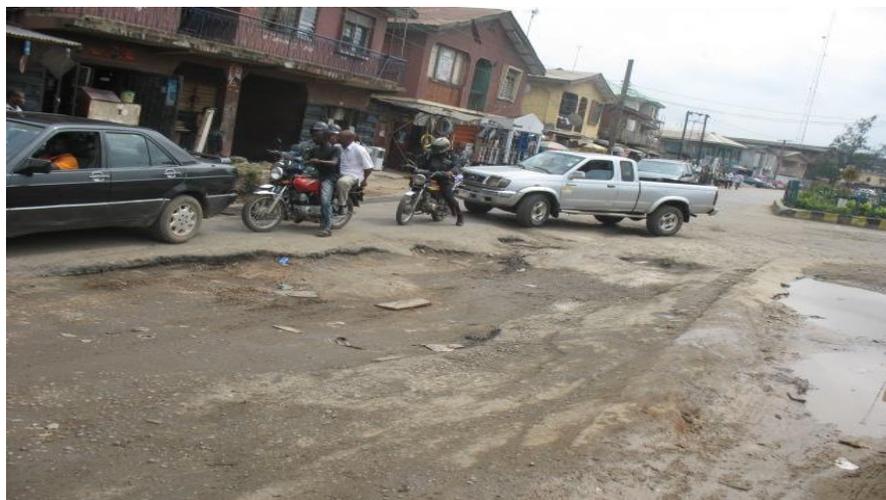
A more worrisome feature and glaring evidence of disrepair of all the roads surveyed is the presence of numerous potholes and failed sections in some cases as Plates 4 and 5 describe. Most of the potholes developed over time, from minor wear-out of road tar on a few spots to very large dimensions, and at some points covering more than half the width and a significant length of the respective roads as Plates 3 and 4 illustrate.

Plate 3: Pothole on Mushin-Isolo Road

Untimely maintenance and low quality of road surface materials are the main underlying explanation for the development of “small size” potholes to “large size” and sometimes, “gully-like” and uncomfortable dimensions. The common experience is that potholes are left unattended to for several months and with continuous use, they deteriorate fast. The poor conditions of the roads show that the roads are yet to receive the attention of LAMATA under the recurrent maintenance approach. As presented earlier, recurrent maintenance is one of the four maintenance approaches of LAMATA’s urban road network efficiency improvement programme. It involves filling or sealing of cracks, repair of potholes, treatment of swellings and depressions on the roads. Related to this, is the low quality of road surfacing and maintenance work as signs of road deterioration begin to manifest soon after completion of work. A good example is Idimu Road. Portions of the road that have been recently resurfaced already have many potholes while work is still ongoing on the other parts of the road.

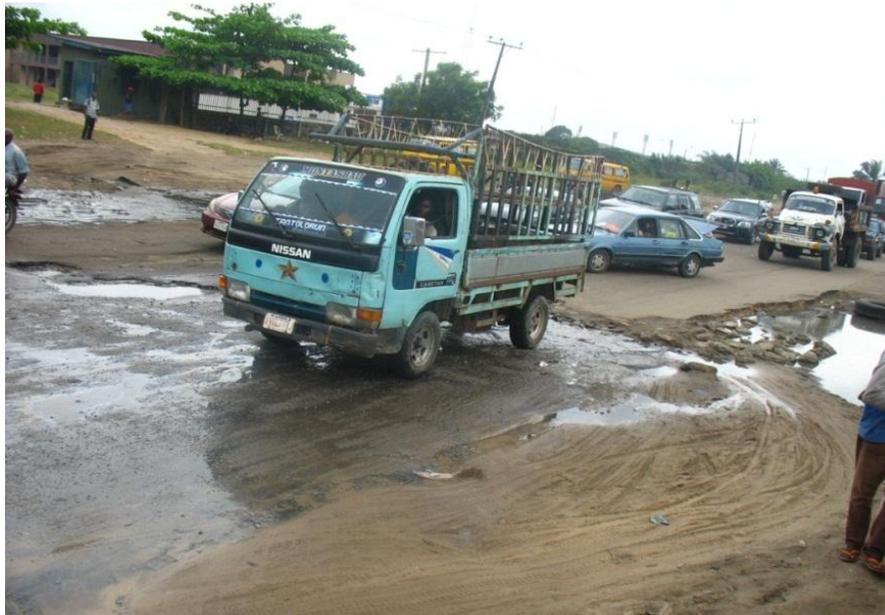
Plate 4: Dilapidated road portion on Mile 2-Badagry Road

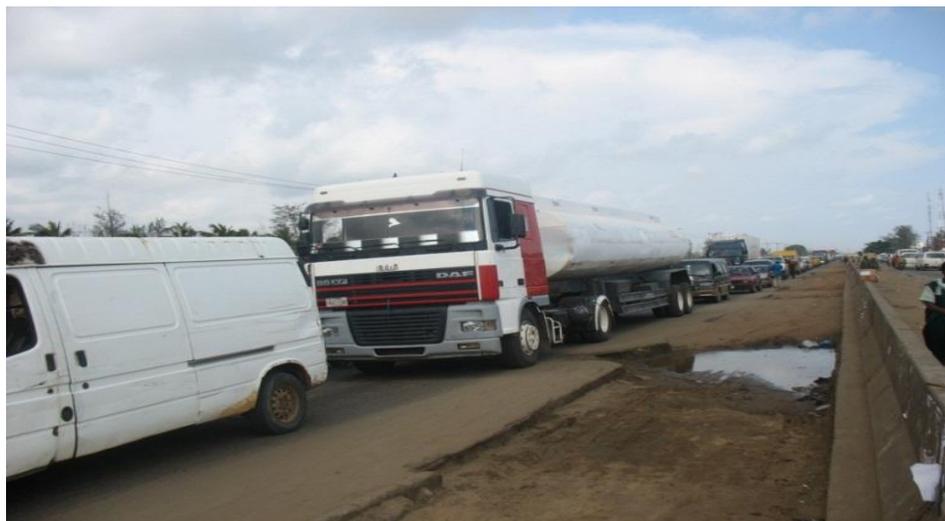
Plate 5: Traffic grid lock on Mile 2-Badagry Road

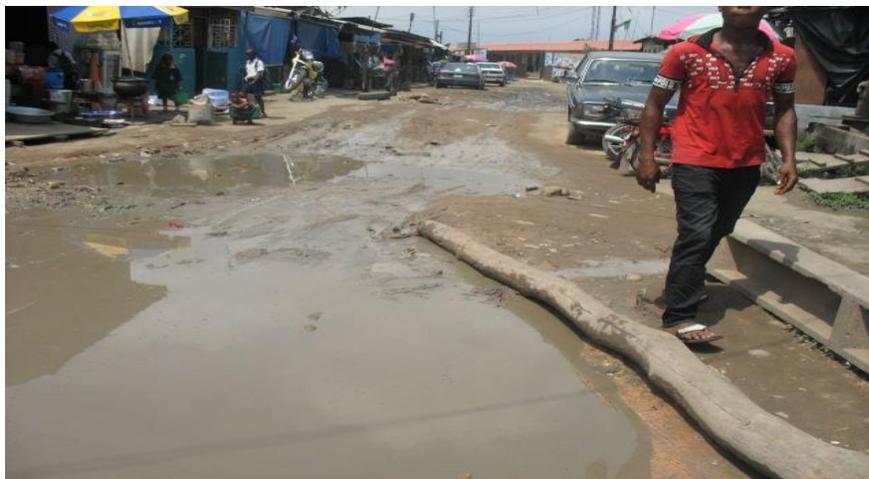
It is pertinent to mention that road users have learnt to mitigate the effects of bad roads. The adjustments include early departure from home to create allowance for anticipated time to be spent on traffic hold up, use of alternative roads where feasible, squeeze through narrow road strip by potholes or drive through the pothole sections very slowly. Passengers of motor bike riders and sometimes, the riders themselves, highlight from the bikes briefly to enable the rider have firm grip of the bike as he wades through the deep and sometimes muddy potholes. Apart from road users, residents whose frontage are very close to potholes/failed sections of the roads often times prevent vehicular access on the remaining part of the road by barricading the road at these portions. Plate 6 describes a barricaded road portion. Occasionally, local communities provide palliative measures mainly in the form of filling of potholes with heaps of dirt, sand and hard core (broken concrete) and in the use of sticks and vehicle tires as signal of very deep potholes.

Plate 6: Water logged pothole condoned off
