# Road Facility Availability and Maintenance in Lagos State, Nigeria

**Key words:** Road facilities, maintenance, road condition, Lagos metropolis

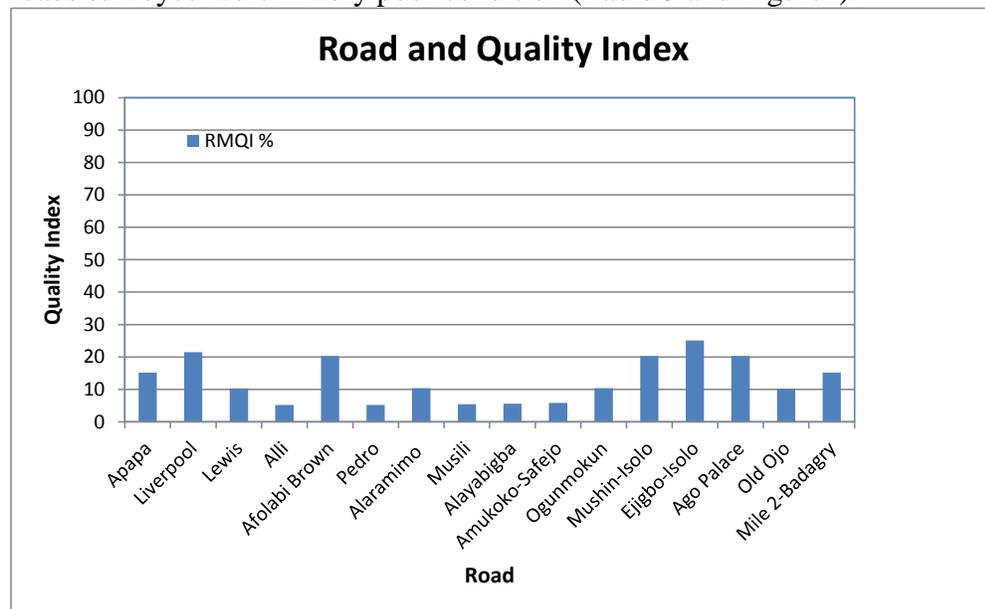
Figure 1: Road quality Index

Furthermore, the RMQI scores I show that all the roads, except one (Ejigbo-Isolo Road) fell within the lowest range of 0 to 0.25 or below 25 per cent, signifying that 93.75 per cent of the roads surveyed were in very poor condition (Table 5 and Figure1).

Ejigbo-Isolo Road may also be regarded as a very poorly maintained road with a score of 25.1 per cent. In other words, none of the road attained the status of good road condition or well-maintained road.
